# Private Client

# Retaining Wall Solution

Domestic Private Property in Somerset

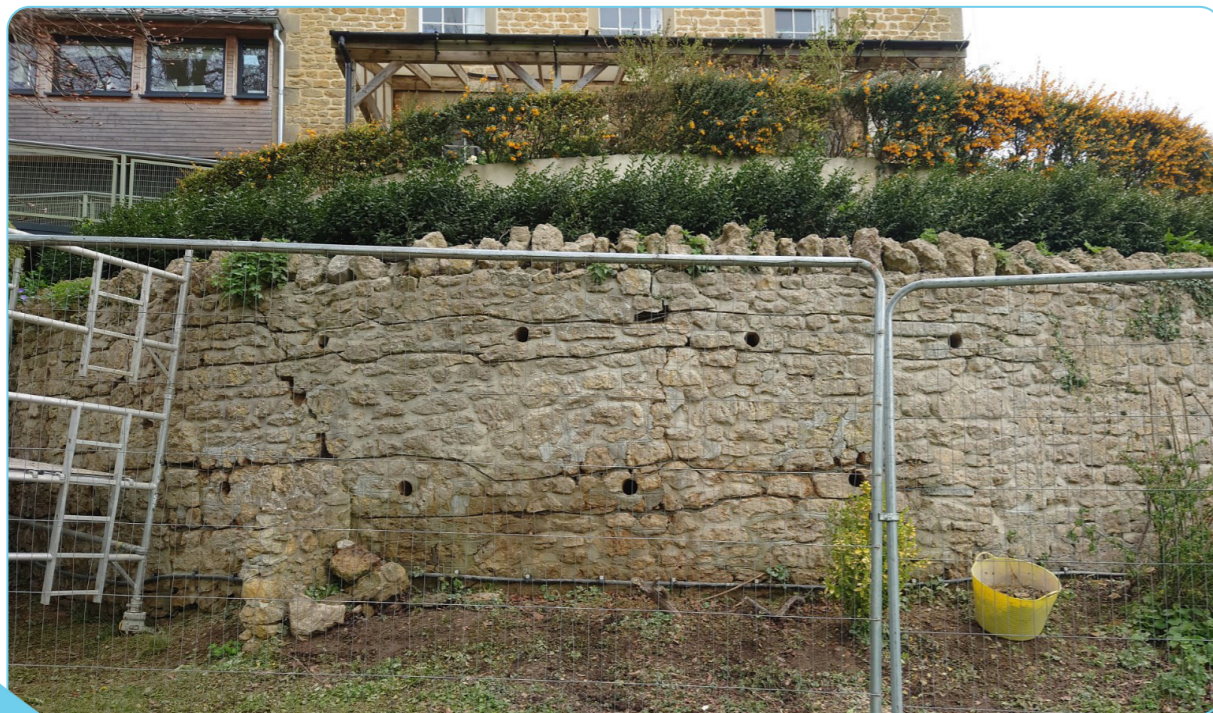
ASRS, our approved specialist installer of Vulcan Earth Anchors, contacted us regarding a client's private retaining wall that was failing in Somerset. A comprehensive survey uncovered a critical concern-an ailing retaining wall exhibiting alarming signs of bulging and cracking. This demanded an immediate and effective solution to avert further deterioration.

Our approach involved a meticulous remedial scheme aimed at not only rectifying the current issues but fortifying the structure against future challenges. Using our handheld equipment, ASRS installed 12 AS-50 Vulcan Earth Anchors, fitted with 4m of 16mm 304 stainless steel tendon, a 250mm x 250mm 304 stainless steel load plate attached with a taper washer, and load nut. Each of these systems were installed at 1.5m intervals across the face of the wall which proved the most suitable solution to ensure the load was held and ensure maximum stability. This work successfully restored the structural integrity of the property, providing substantial resistance to further cracking and leaning in the future.
