Project Report

As part of Network Rails asset repair and refurbishment programme Lucy's Bridge was selected for repairs. Lucy's Bridge is the only pedestrian and single vehicle access to a local housing estate and Caravan Park in Burgess Hill, West Sussex. Suttle Projects were awarded the contract to provide the repairs to the structure based on the survey and subsequent recommendations of Engineer Crouch Waterfall & Partners. The wing walls were identified as having a number of repairs to the brickwork, brickwork mortar and coping units.

Number of anchors: 68 AS90 Stainless steel anchors

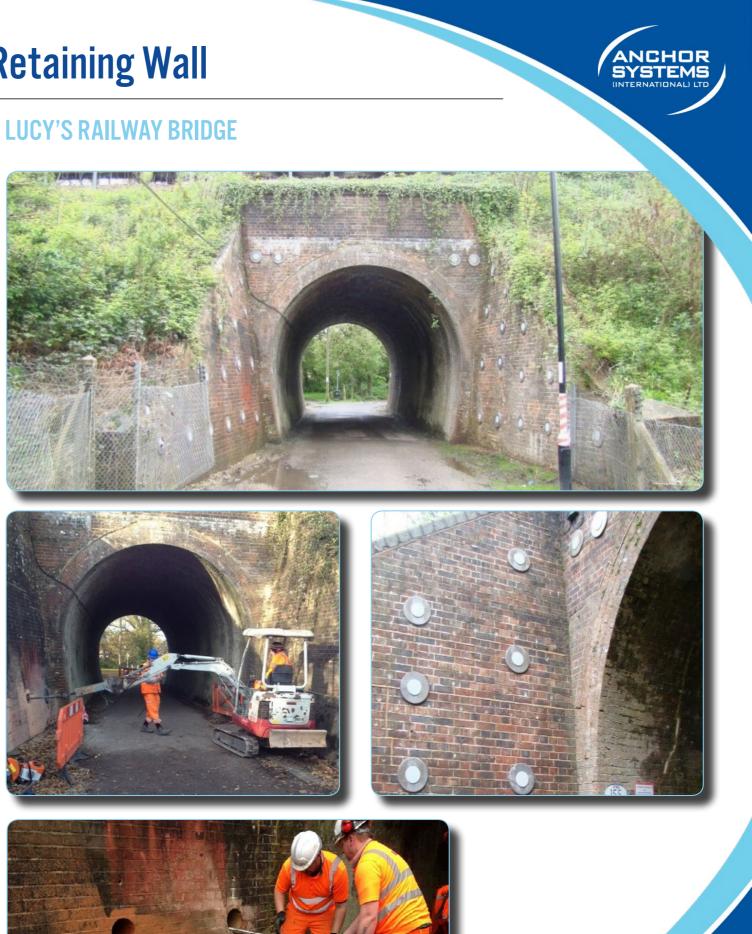
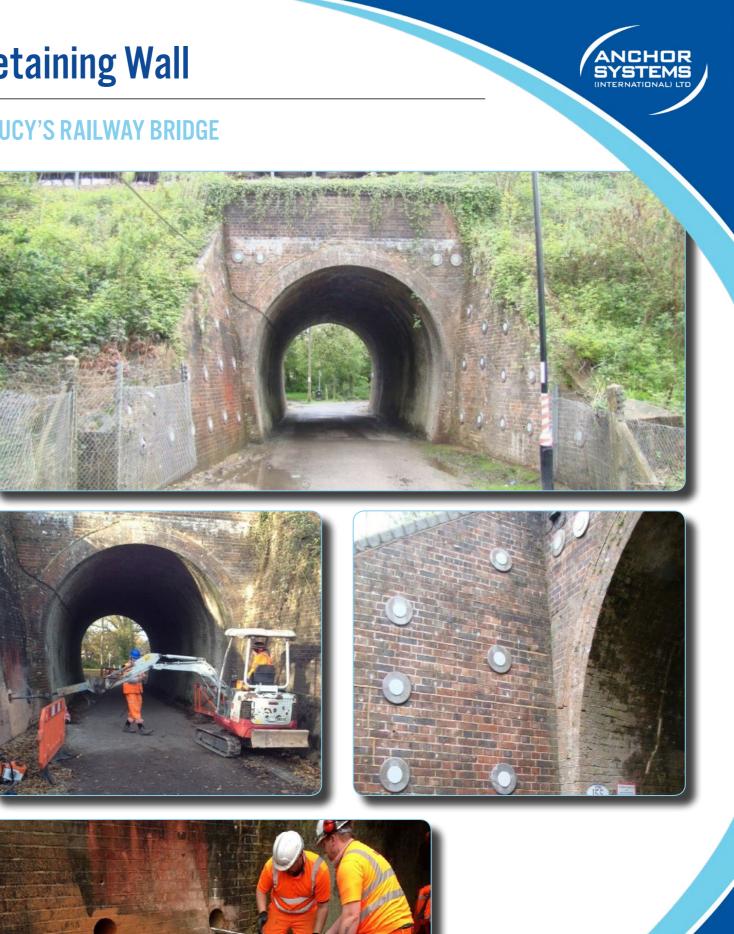
Retaining Wall

The Vulcan Earth Anchor System was identified by the Engineer as a system of choice to stabilise all four wing walls and both spandrel walls. A complete stainless-steel Vulcan solution has been designed and developed to ensure the longest durability based on the aggressive nature of the soils adjacent to the railway structure. Suttle Projects had a number of challenges on the project and the most important was keeping the access open to cars and pedestrians while working in a limited access area.

The Vulcan system was also employed with ASIL's specialist recessed pattress plates commonly used in pedestrian zones. After the verification process ASIL were engaged to supply four stainless-steel Vulcan test anchors and the attendance of our Site Supervisor to support and assist in the installation and loading of the test anchors.
